Klondike Passive Treatment System Investigation Babb Creek Watershed, Tioga County

Technical Report Provided by Hedin Environmental through the Trout Unlimited AMD Technical Assistance Program

August 18, 2009

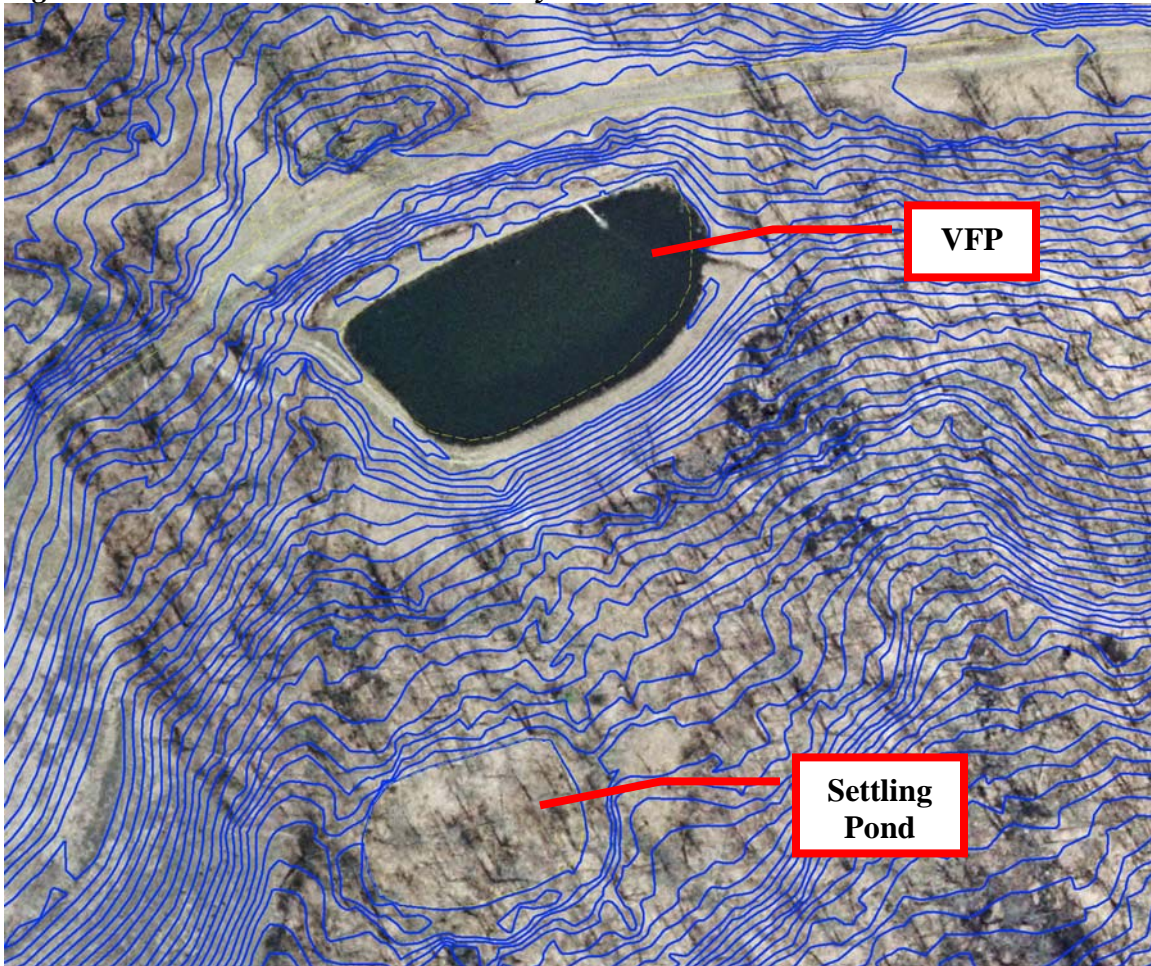
Figure 1. Klondike Passive Treatment System

Figure 1 shows the layout of the system. The VFP has a water surface area of 2,600 m². The settling pond is visible in the topographic contours, but not in the aerial photography because the pond was constructed between the acquisition of photography and elevation data.

Based on construction photos and discussions with BCWA it is apparent that neither the VFP bottom nor VFP substrate (limestone, compost) were installed level. In fact the bottom of the VFP appears to be sloping in the opposite direction from the top of the substrate. It is very likely that the thickness of treatment substrate varies widely and, as a result, creates zones of preferential flow through the thinner areas.

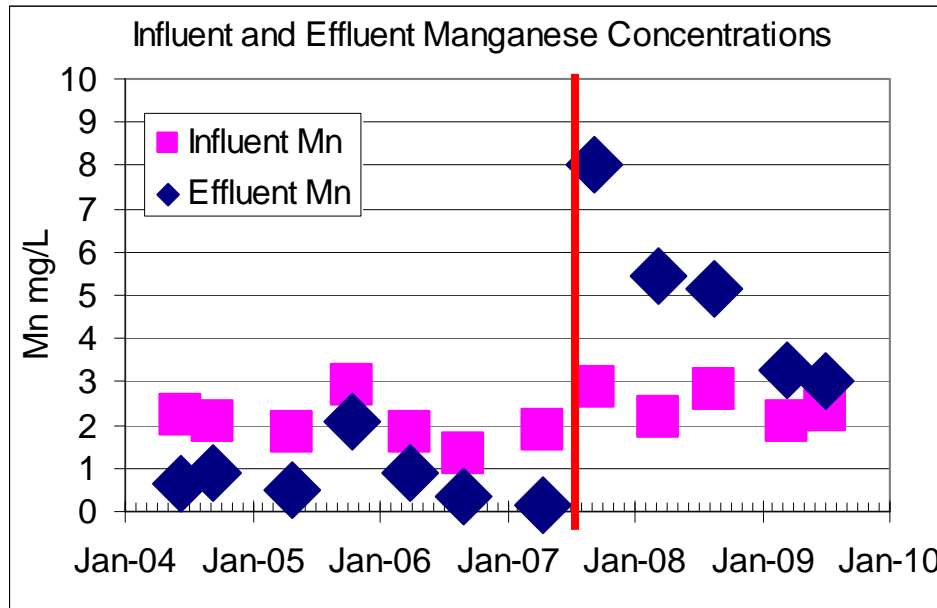
Figure 2. Manganese concentrations before and after compost replacement

Many of the metals solids that formed in the limestone layer under oxic conditions are soluble under reducing conditions. As a result, metals solids are going back into solution causing the system to discharge water having higher manganese concentrations than what is entering the system. Iron now passes through the system due to the reducing conditions. Since the system is no longer removing manganese and iron (and their associated acidity) the acidity removal rate is lower.

Figures 2 and 3 show the influent and effluent iron and manganese over time. The system appears to be stabilizing in terms of manganese release. Nonetheless, it is evident that even once stabilized the system will suffer from short-circuiting problems.

The red line indicates the approximate date of compost replacement.

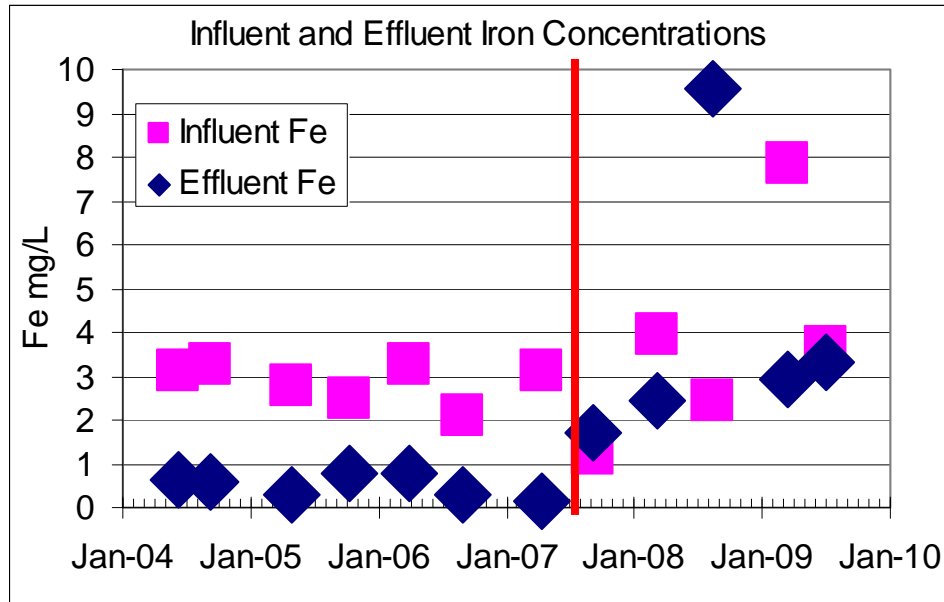
Figure 3. Iron concentrations before and after compost replacement

The red line indicates the approximate date of compost replacement.

Clearly the replacement of the compost layer changed the chemical performance of the system. However, there is some indication that the physical function of the system was altered as well. The effluent water is turbid with orange suspended solids. One potential cause of this could be a hydraulic short-circuit. Acidic, aerobic water is reaching the underdrain plumbing where it mingles with alkaline treated flow. Once mixed, iron precipitates from the solution forming the visible solids in the effluent.
