# **Sterling Run AMD: Conceptual Passive Treatment Recommendations**

## **Technical Report prepared by Hedin Environmental through the Trout Unlimited AMD Technical Assistance Program TUTAG-24**

**June 2007**

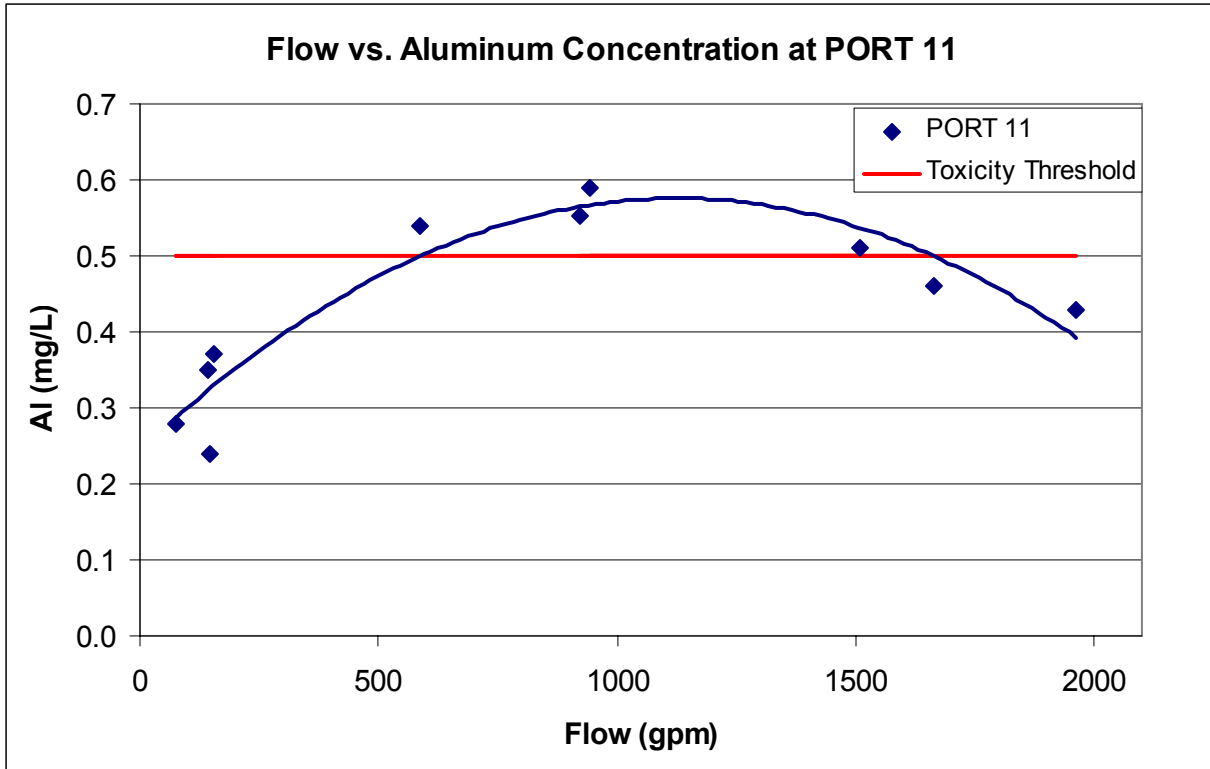
**Figure 1. In-stream relationship of flow rate and aluminum concentration at PORT 11.**

Data collected at PORT 11, an in-stream monitoring point immediately downstream of the known AMD contributions, shows a stream that is chemically capable of supporting aquatic life much of the time but suffers from episodes of water with higher acidity and aluminum concentrations. Aluminum is of particular concern because it is known to be toxic to fish and benthic macroinvertebrates at concentrations as low as 0.5 mg/L. In times of low flow, the discharges are dry and stream water quality improves. Likewise, in times of high surface runoff, the effect of the discharges is diluted leading to improved water quality. However, in the intermediate flow condition, when surface runoff is low but discharge flows are high, the stream suffers poor water quality. Figure 1 shows the relationship between instream concentrations of aluminum and flow rate.

Flow rate into the system should be restricted to the design maximum flow rate of 150 gpm and any excess bypassed to the existing channel below PORT 14. During high flows the impact of AMD on the stream is reduced so bypass of excess untreated AMD is acceptable (See Figure 1). To limit the total maximum flow into the system to 150 gpm, the PORT 13 discharge should be limited to 30 gpm and the PORT 14 discharge should be limited to 120 gpm. These numbers were based on the observed flow rates on January 22, 2007. The treatable flow rate from PORT 13 is greater than the January 22 flow rate based on the likelihood that additional flow will be captured during installation of the collection system.

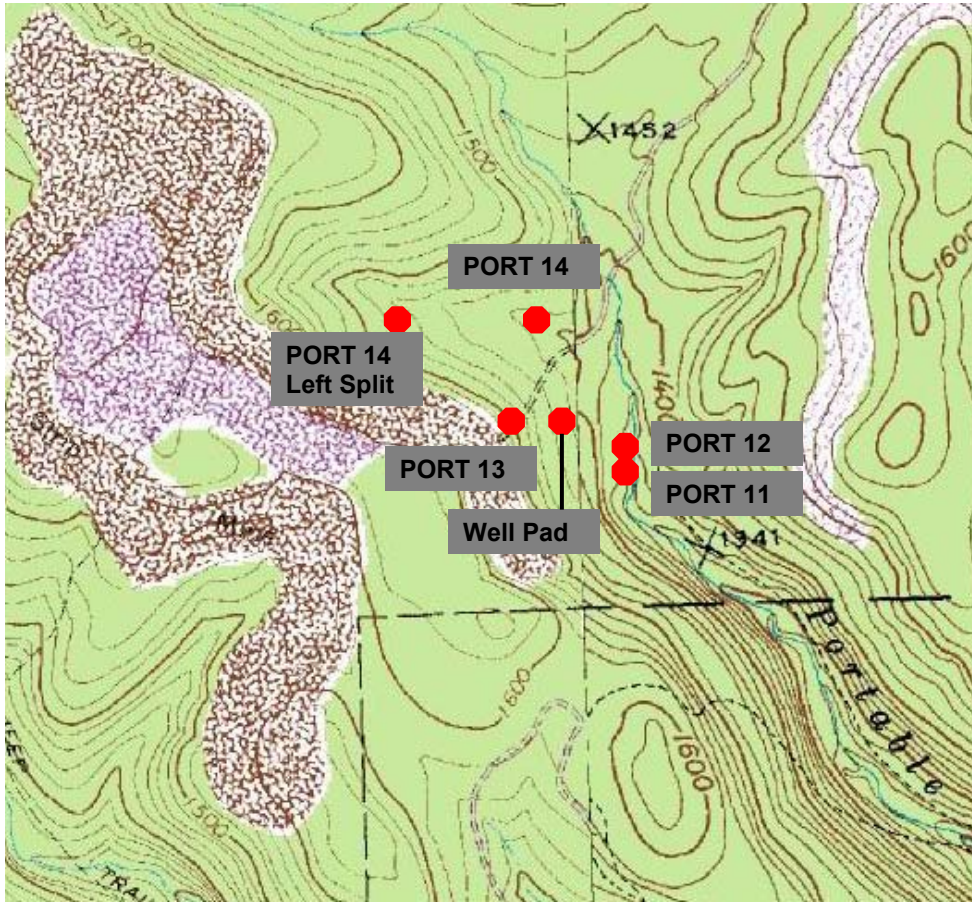
**Map 1: Sampling Locations**

The discharges that are the subject of this TAG were identified in the Assessment as PORT 13 and 14. Discussion of PORT 12 is also included due to its close proximity to PORT 13 and 14 and their common source (See Map 1).

During the site visit it was noted that the flow in the PORT 13 and 14 channels increased below the monitoring locations. A flow rate measured where the PORT 13 discharge crosses under the logging road confirmed that the flow rate had increased from 31 gpm to 61 gpm. A small contributing flow of water was observed to be emanating from a recently constructed drilling pad. An analysis of a sample of this flow is shown in Table 3. The nature of the channel prohibited flow rate measurement but the flow was estimated to be less than 10 gpm – far less the 30 gpm observed increase in flow. The water quality of the flow from the well pad revealed that it is indeed AMD as shown in the following table.

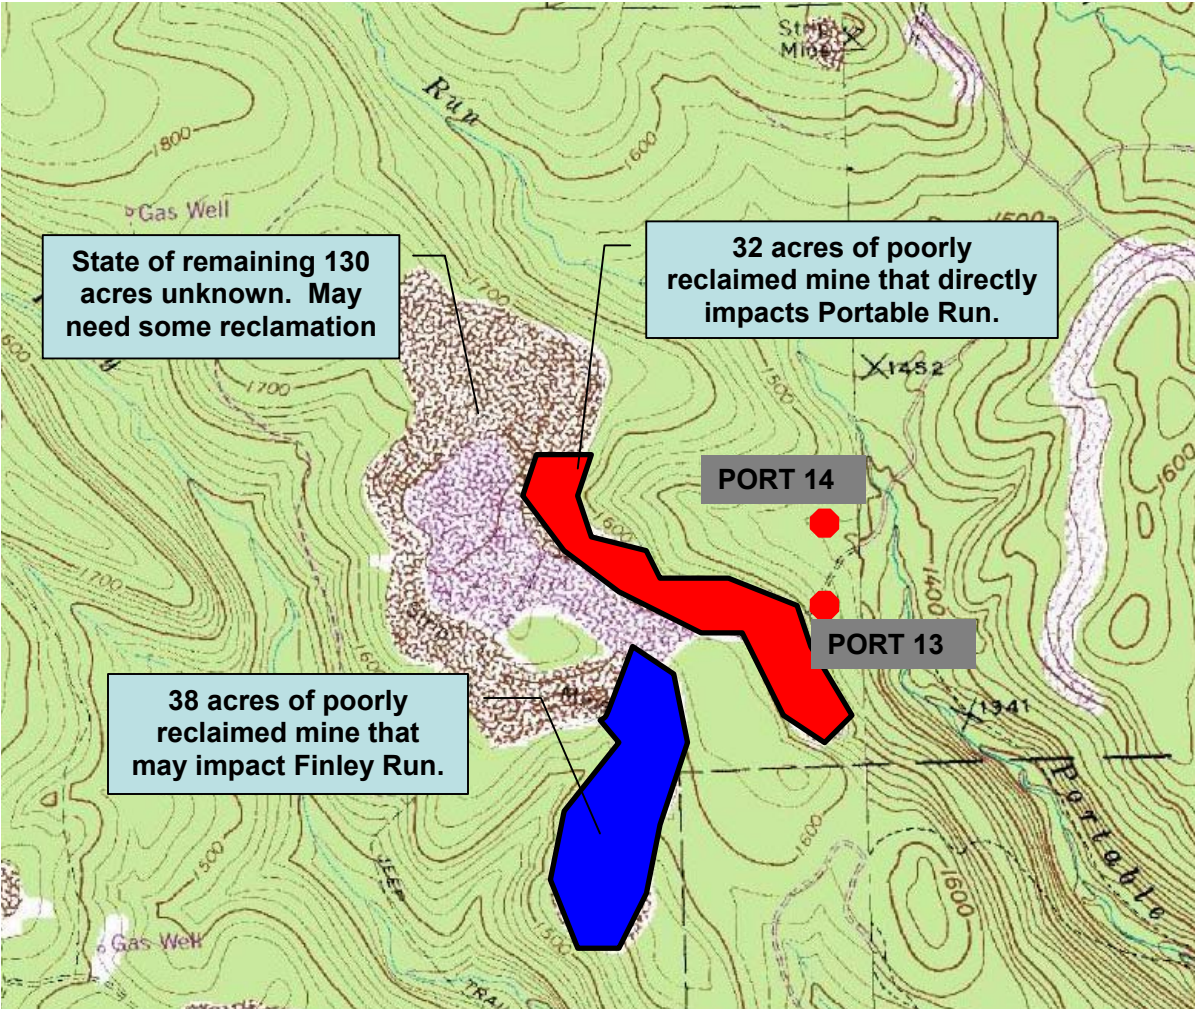
**Map 3: Preliminary Reclamation Recommendations**

Approximately 200 acres of land has been surface mined according to the West Creek USGS quadrangle map (Maps 3 and 4). Only a small area of the mine upslope of PORT 13 was explored as a part of this study. This area is a poorly reclaimed “shoot and shove” surface mine. That is, the miner dynamited (shot) the overburden and simply shoved it downslope creating large spoil piles over the outcrop of the coal as well as vertical highwalls. The implication of this is that the large spoil piles obstruct runoff from the mine and direct runoff toward the open pit where it becomes acidified. It is likely that infiltration rates in some portions of the surface mine approach 100%. The spoil piles themselves are likely the primary source of AMD.

The Assessment listed reclamation targeting the PORT 12 discharge as the second highest priority (with treatment of PORT 13 and 14 as the highest priority). Passive treatment of the PORT 12 discharge is not practical due to its close proximity to the stream. However, it is likely that reclamation will impact not only the PORT 12 discharge but also the PORT 13 and 14 discharges depending on how the extent of the reclamation project. If reclamation is chosen as a remediation strategy, it should be conducted before treatment systems are constructed so that treatment system designs will be appropriate for post-reclamation conditions.

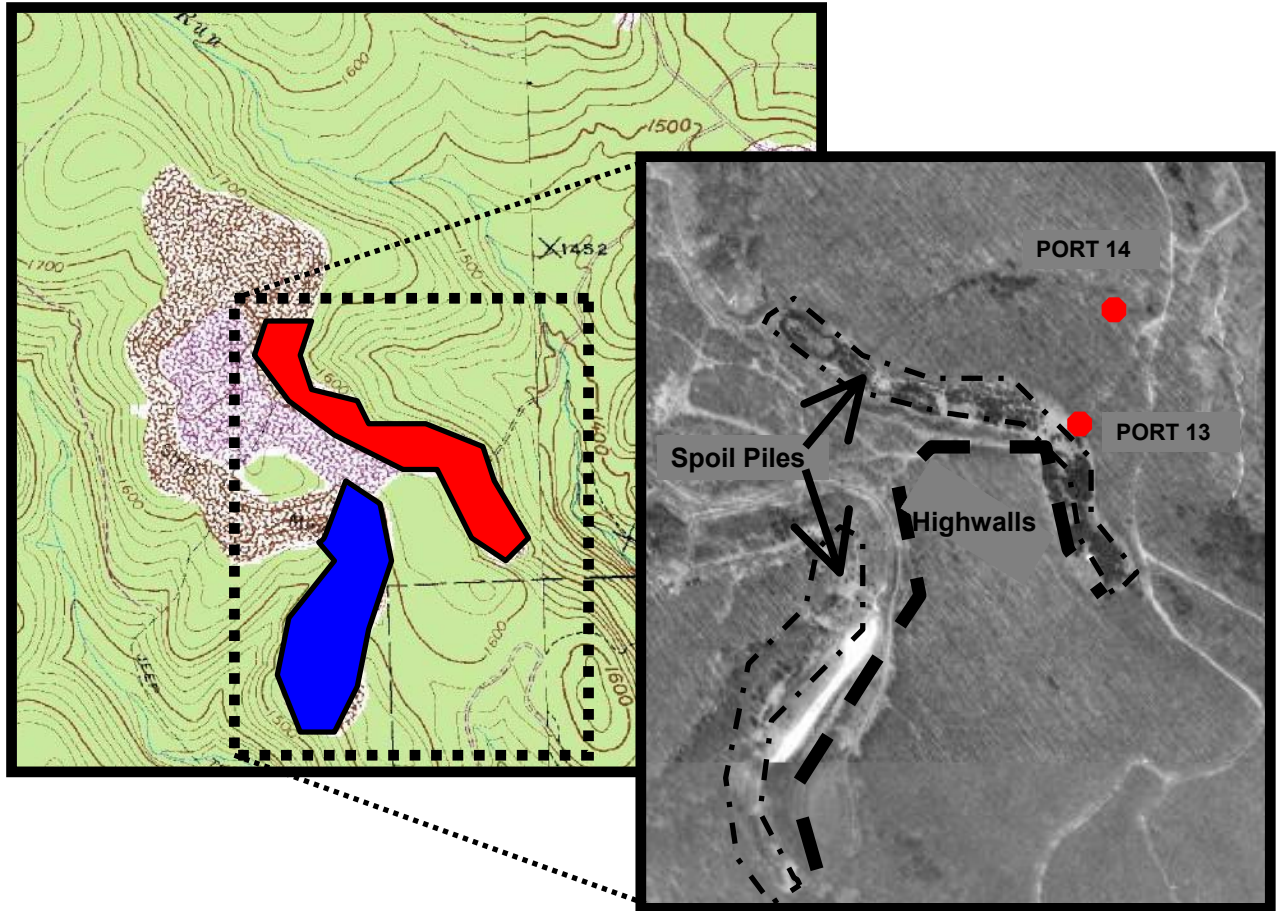
Map 4: Air Photo Showing Known Unreclaimed Surface Mine Features

It is difficult to estimate the amount of effort and cost that such a reclamation project would entail. Based on the limited information that can be obtained from the single site visit and from airphotos (Map 4), it appears that at least 32 acres of surface mine contribute directly to the Port 11/12/13 discharges and should be reclaimed. In addition, approximately 38 acres of surface mine on the Finley Run side of the surface mine appears to be in a poorly reclaimed state. Although no surface discharges have been identified emanating from this surface mine, benefits to Finley Run could be realized through reclamation by reducing or eliminating contaminated baseflow. Reclamation of the surface mine on Finley Run are not discussed here.
