Anna S Refuse Pile and Wilson Creek Evaluation Babb Creek Watershed, Tioga County

June 25, 2010

**Technical Report Provided by Hedin Environmental through the
Trout Unlimited AMD Technical Assistance Program**

Biological Assessment for Wilson Creek Babb Creek Watershed, Tioga County

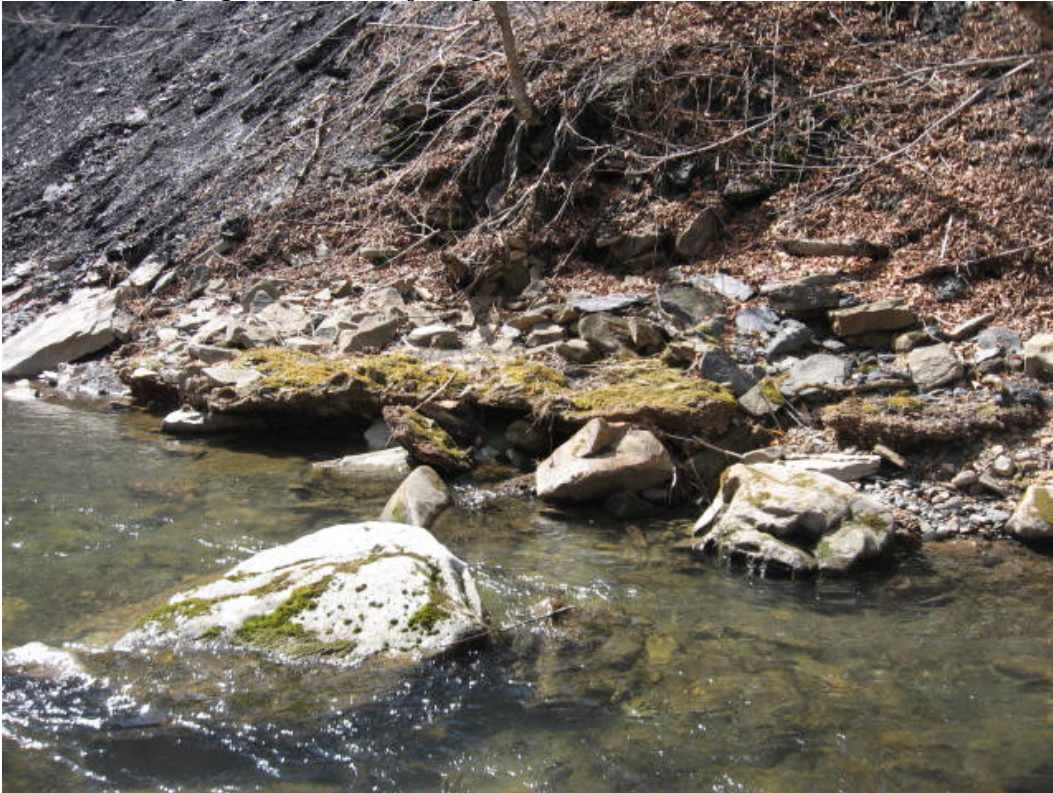
Photo 1. Sample point above refuse pile

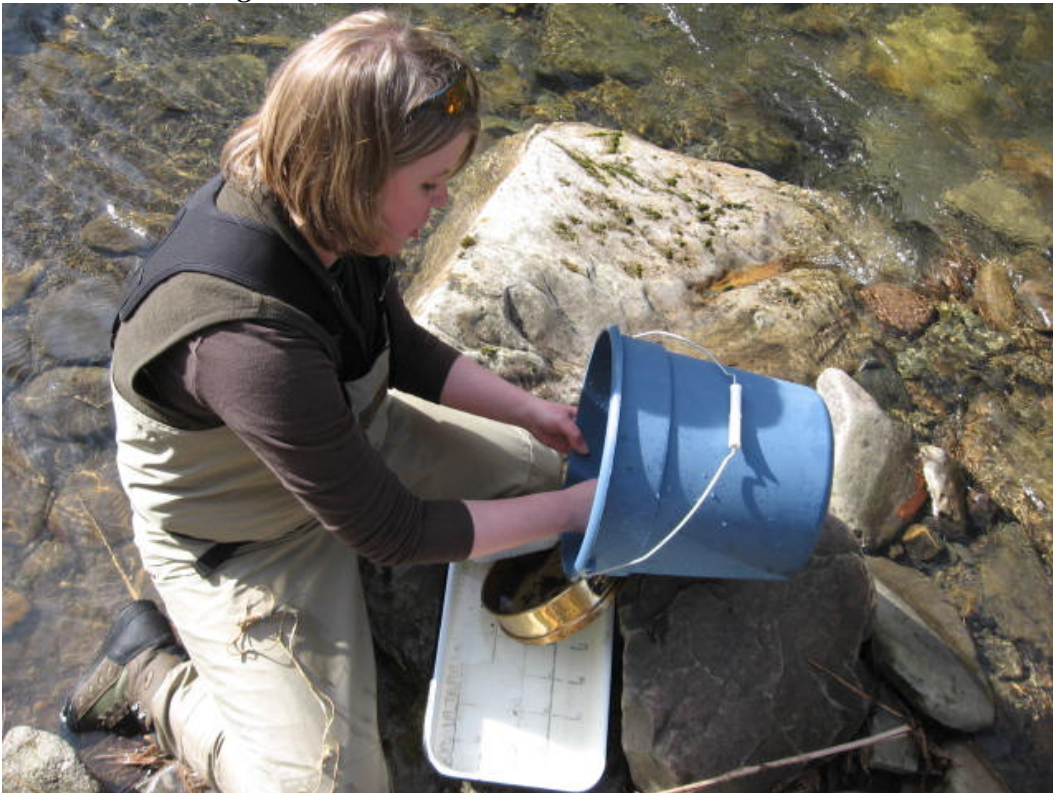
Photo 2. Collecting macroinvertebrates

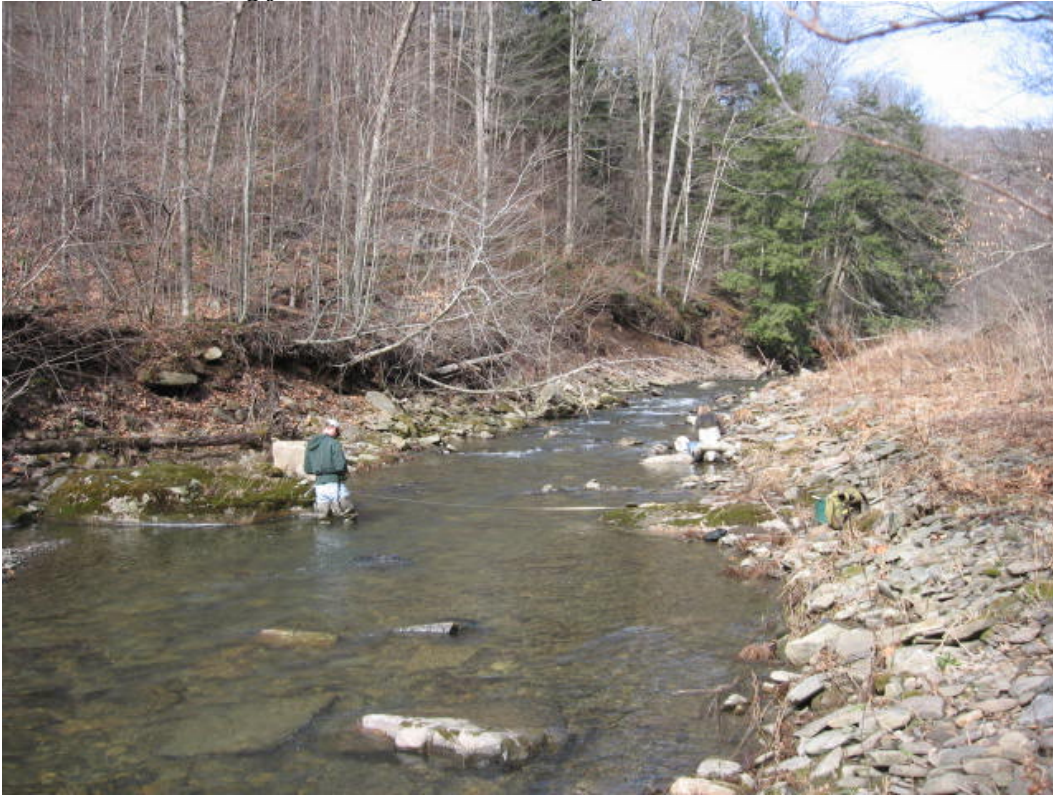
Photo 3. Measuring flow at Point above Bridge Run

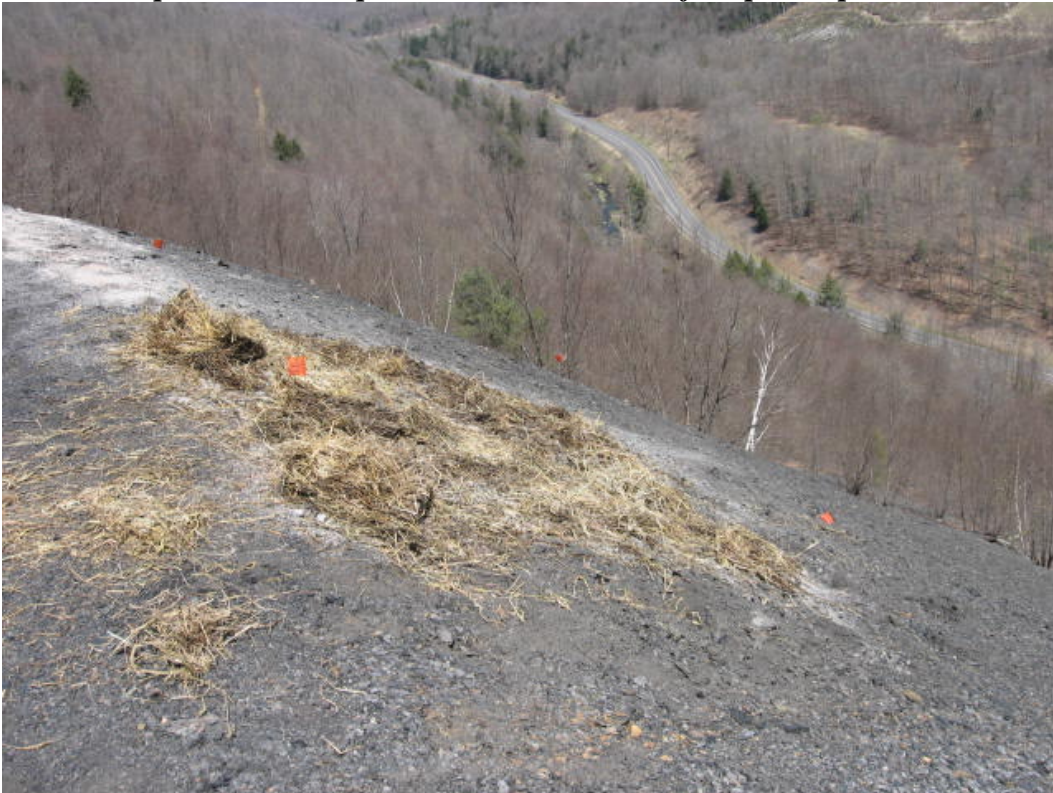
Photo 4. Experimental test plots on Wilson Creek refuse pile slope

PA¹. A similar approach for the Wilson refuse pile would be very inexpensive. On April 27, 2009 three test plots were prepared on the refuse. The first test plot measuring 10 feet by 10 feet was located on top of the refuse pile overlooking Wilson Creek marked out with orange steel flags. The site was prepared by raking the surface of the spoil with a standard garden rake while adding 10 pounds of agricultural lime and 5 pounds of 10-10-10 fertilizer to the surface (see Photo 4). Several flakes of hay mulch were then spread onto the surface to help trap seeds soon to be dispersed from local aspen and birch. A second plot identical to the first was prepared on the side slope facing Wilson Creek starting at the top edge. A third site was prepared at the top of the slope on the pile and consists of a 50 foot long strip 2 feet wide. A rake was not used to break up the spoil and no mulch was used. Approximately 20 pounds of agricultural lime and 5 pounds of fertilizer were applied to the surface. The plots were investigated in May and June 2009. No colonization by trees into the plots was observed at that time. Tree seedlings were observed in shaded fringe areas outside the study plots suggesting that shade provides more moisture for the seedlings to be established. The black refuse surface may result in extreme surface temperatures that inhibit colonization by trees, even with moderation of surface chemistry through lime, fertilizer and mulch. If BCWA wishes to revegetate the refuse pile, it will need to implement standard refuse revegetation procedures.

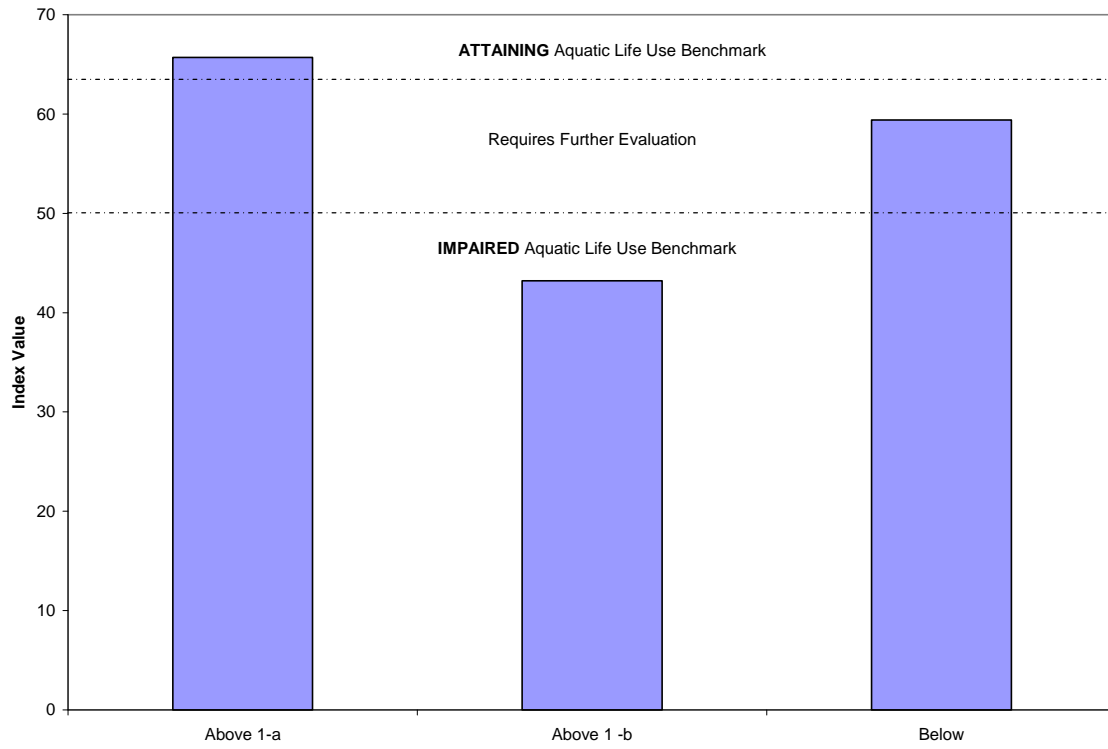
Figure 4. Index of Biological Integrity Values

The aforementioned IBI score was the highest measured amongst the sites sampled in this survey (Figure 4).

The IBI score at this site is lower than the most upstream site but higher than the score at the site located directly above the refuse pile (Figure 4). Given that field water chemistry values are similar it is again hypothesized that this change in score is a reflection of habitat instead of water quality.

Wilson Creek at the Delmar Township Line contained the most robust benthic macroinvertebrate population. A marked decrease in IBI scores was noted downstream. However, the highest degree of reduction in the IBI score is noted between the Delmar Township Line and the site where the Mitchell discharge historically entered Wilson Creek. Rather than continuing to decline though, the IBI score increases between the historical Mitchell discharge site and the site located below the refuse pile.

Subsequently, the change in benthic populations is believed to be more correlated to habitat degradation from the historical Mitchell discharge rather than water quality impacts from the refuse pile.
