Evaluation and Recommendations for Bear Run Passive Treatment Systems, Bloss Township, Tioga County

**Technical Report provided by Hedin Environmental through the
Trout Unlimited AMD Technical Assistance Program**

May 2009

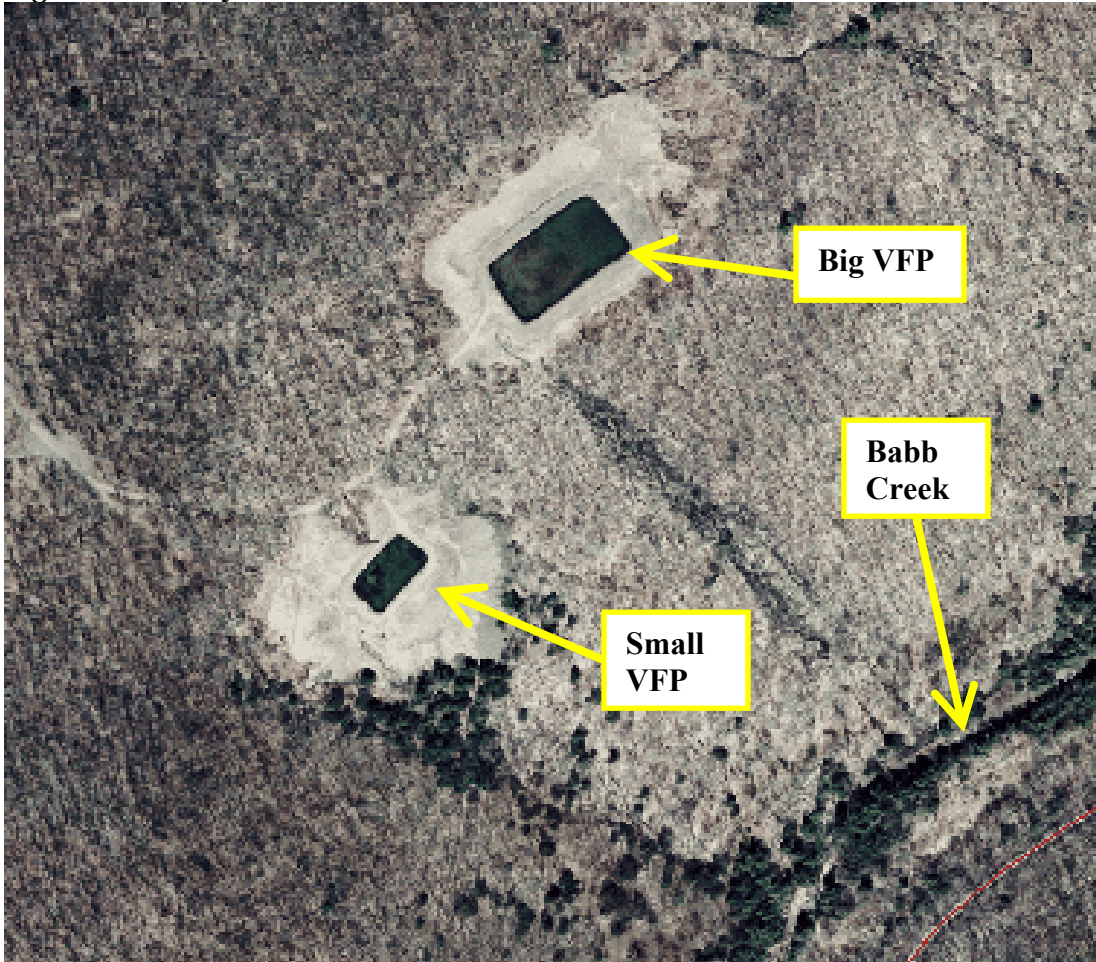
In February of 2009 the Babb Creek Watershed Association (BCWA) requested technical assistance in the form of a determination of maintenance requirements for the Bear Run Passive Treatment Systems. There are two separate passive treatment systems that treat discharges from the Bear Run mine complex site (Figure 1). Each system consists of a single Vertical Flow Pond (VFP) that discharges to Babb Creek. Although the two systems are identical in construction, one VFP is roughly three times larger (by area) than the other. The systems were constructed in 2000 by Stotts Coal Co. as part of a consent order and have consistently produced net alkaline effluent with few metals. In 2005 the organic substrate in both systems was mixed in response to an apparent loss of permeability. The mixing of the organic substrate improved the permeability and the systems continue to produce excellent water quality. Despite the net alkaline effluent further maintenance is inevitable. The purpose of this Technical Assistance is to investigate the systems by analyzing available water quality data and also through excavations of the organic substrate to determine the appropriate course of action to ensure continued system performance.

Figure 1. Site layout

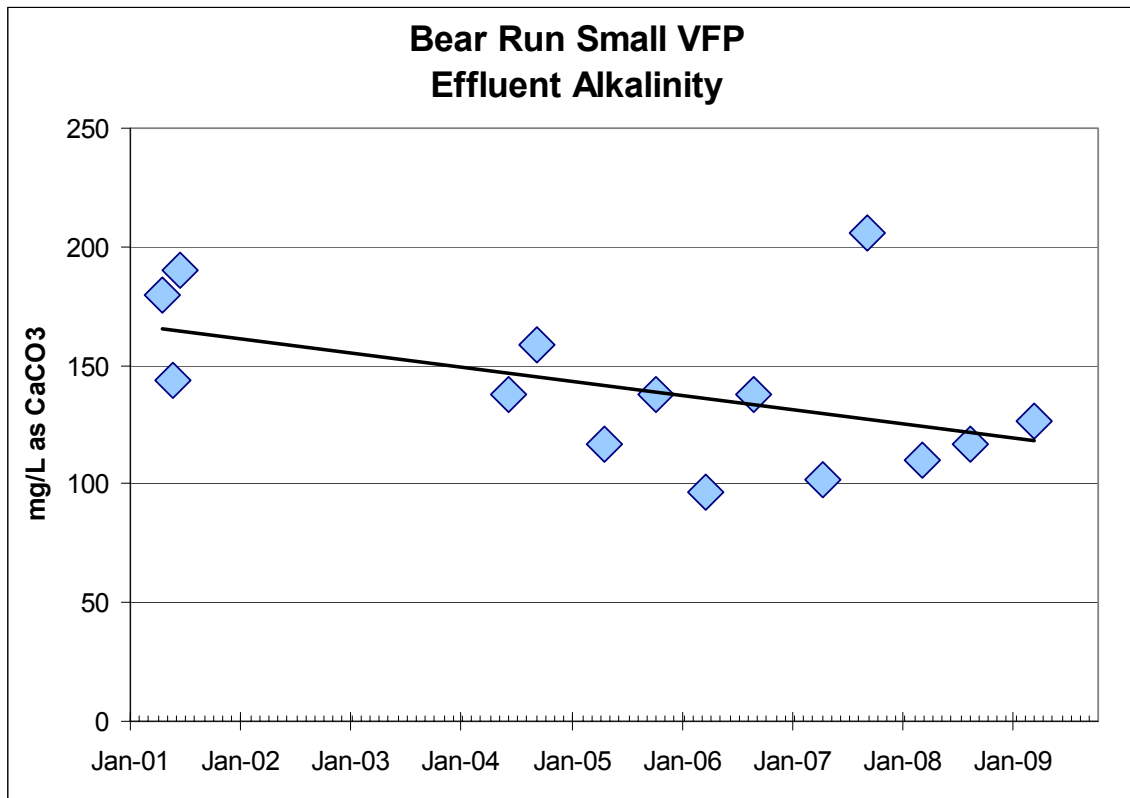
The Small VFP is not overloaded in terms of acidity per unit area with an average loading of 17 (g/m²)/day. Typically, VFPs are designed to receive 35-40 (g/m²)/day of acidity loading. The modest loading rate has allowed for highly reliable performance for nearly a decade. However, a trend of decreasing effluent alkalinity is apparent in the data (Figure 2). The trend is gradual and is a natural part of the life cycle of passive treatment systems. Future maintenance is required to maintain treatment system effectiveness but the risk of net acidic discharge is quite small for years to come.

Figure 2. Small VFP effluent alkalinity over time

The existing sampling regimen should be continued. Effluent alkalinity is perhaps the most significant parameter to consider for these systems. While a downward trend exists, any significant deviation from that trend should trigger additional sampling.

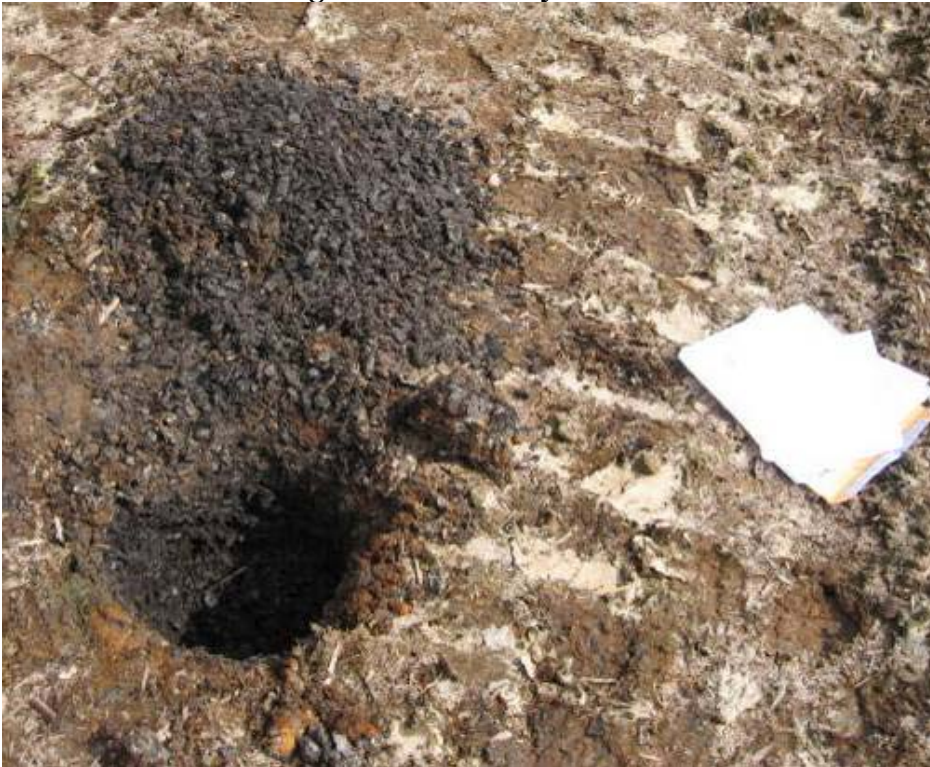
On March 27, 2009 the Small VFP was drained to allow access to the system's contents for investigation. A shovel was used to dig holes through the organic substrate layer to the top of the limestone layer. The thickness of the organic substrate layer was found to be approximately 18 inches or 6 inches less than what was originally specified. This is likely the result of compaction and consumption of the materials by the treatment process. Photo 1 shows one of the holes. The organic substrate layer contained very little visible SMC and was made up largely of limestone aggregate and wood chips. Only minor metals accumulation was noted on the top of the organic substrate layer. The material has compacted over time and has reduced permeability, though not enough to prevent treatment of the full discharge flow.

Photo 1. Small VFP organic substrate layer contents

The recommended action is to physically disturb the full thickness of the organic substrate layer in both systems. The specified thickness of the organic substrate layer was two feet. Test holes dug in the organic substrate layer reveal that it has compacted to approximately 18 inches. The full thickness of the organic substrate layer should be mixed to reestablish permeability. Care should be taken to produce a final surface that is regular, level and protected from compaction.

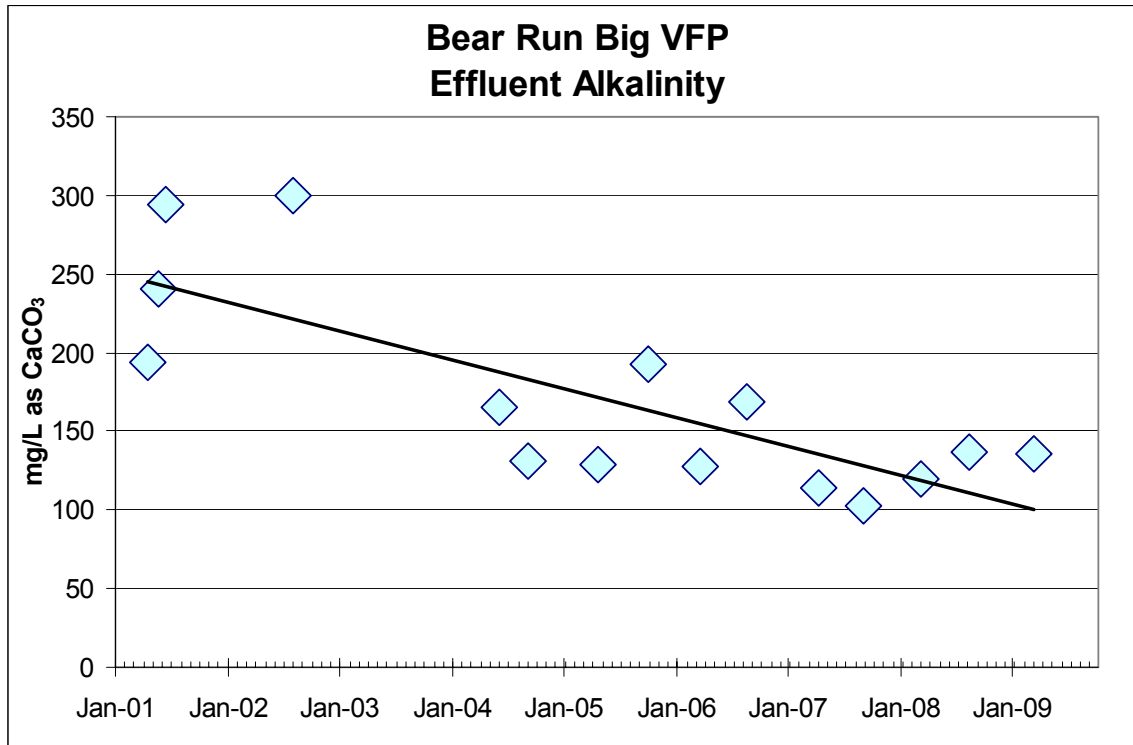
The Big VFP is not overloaded in terms of acidity per unit area with an average loading of 22 (g/m²)/day. Typically, VFPs are designed to receive 35-40 (g/m²)/day of acidity loading. The modest loading rate has allowed for highly reliable performance for nearly a decade. However, a trend of decreasing effluent alkalinity is apparent in the data (Figure 3). The trend is gradual and is a natural part of the life cycle of passive treatment systems. Future maintenance is required to maintain treatment system effectiveness.

Figure 3. Big VFP effluent alkalinity over time

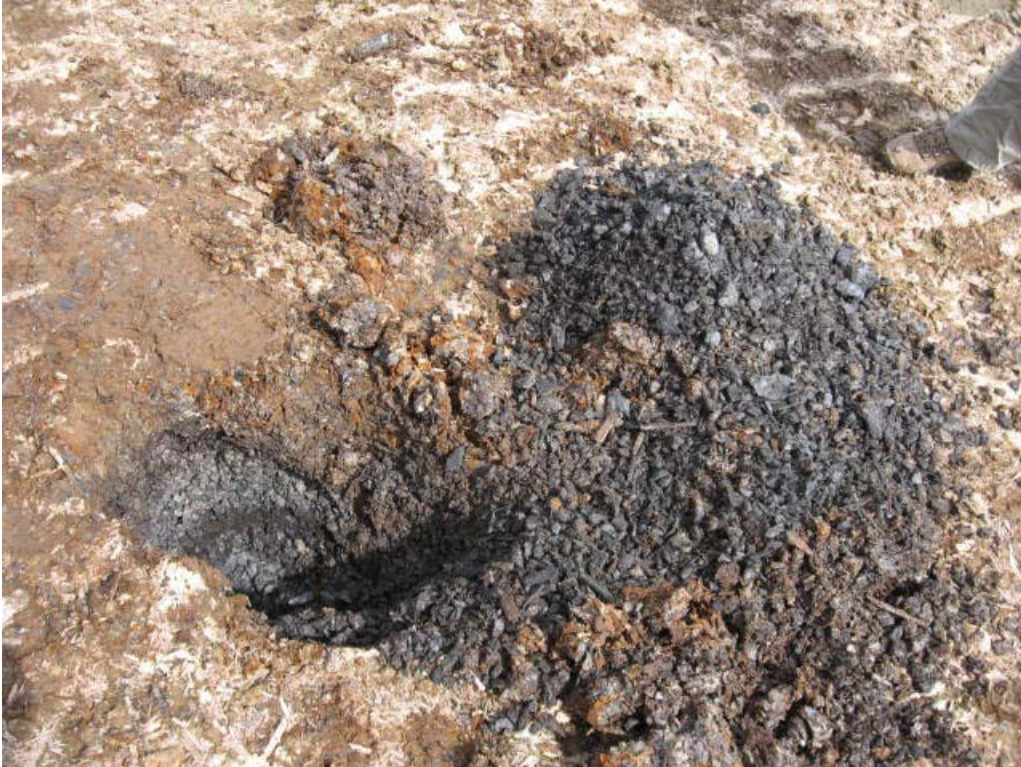
On March 27, 2009 the Big VFP was drained to allow access to the system's contents for investigation. A shovel was used to dig holes through the organic substrate layer to the top of the limestone layer. Photo 2 shows one of the holes. The organic substrate layer contained very little visible SMC and was made up largely of limestone aggregate and wood chips. What little SMC that was found occurred in a thin layer about one foot below the surface. This thin layer of SMC was probably an isolated pocket that wasn't completely mixed during construction. The top 2-3 inches of material was cemented with metals solids (Photo 3). Much of the organic substrate had standing water on top of it despite the fact that the system was drained (Photo 4). The permeability of the organic substrate layer is very low.

Photo 2. Big VFP organic substrate layer contents

The organic substrate layer is intended to maintain reducing conditions within the underlying limestone layer. However, the organic substrate layer was found to be completely lacking in SMC yet the system’s performance has not suffered. As a result the need to augment the systems with additional SMC appears to be low. High material costs at this remote site make it important to establish that SMC addition is necessary before proceeding with a plan to add more SMC. For this reason it is recommended that no additional SMC be added until after the organic substrate layer is mixed and the results considered.

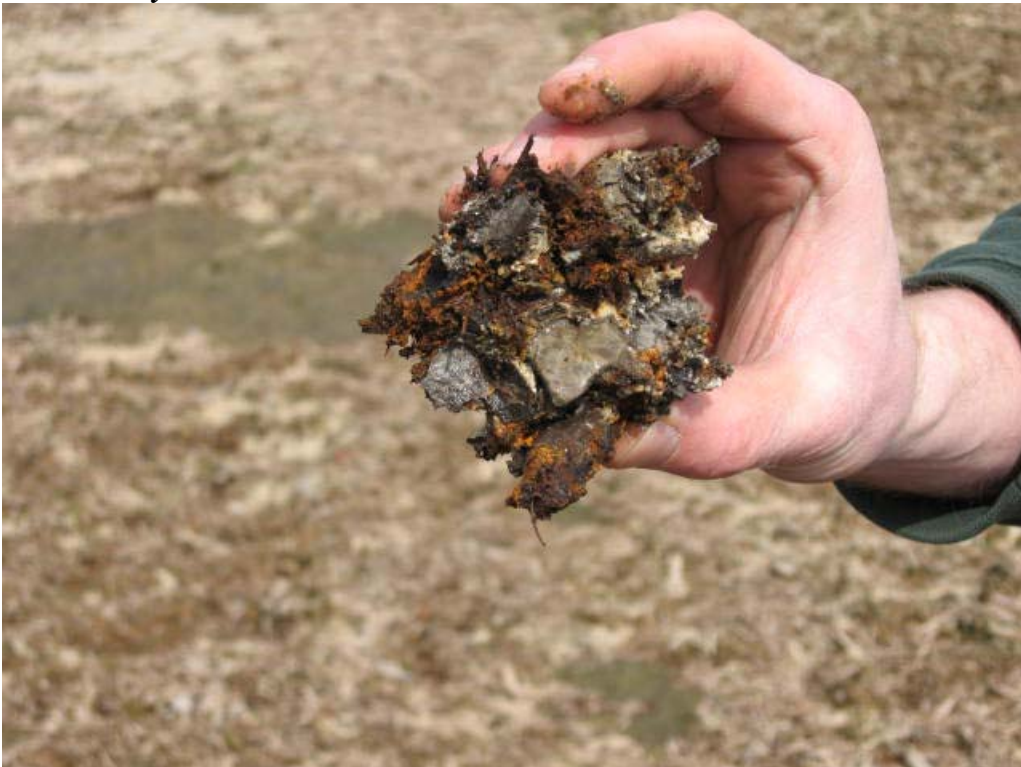
Photo 3. Materials cemented by metals solids at the top of the Big VFP organic substrate layer

The decline in acidity over time was largely driven by the 51% decline in iron concentration. This is critical to system maintenance interval because the permeability loss observed in the Big VFP appeared to be largely due to an accumulation of iron solids in the top 2-3 inches of the organic substrate layer. If the system receives less iron the time required for this problem to redevelop will be greater and thus so will the maintenance interval.

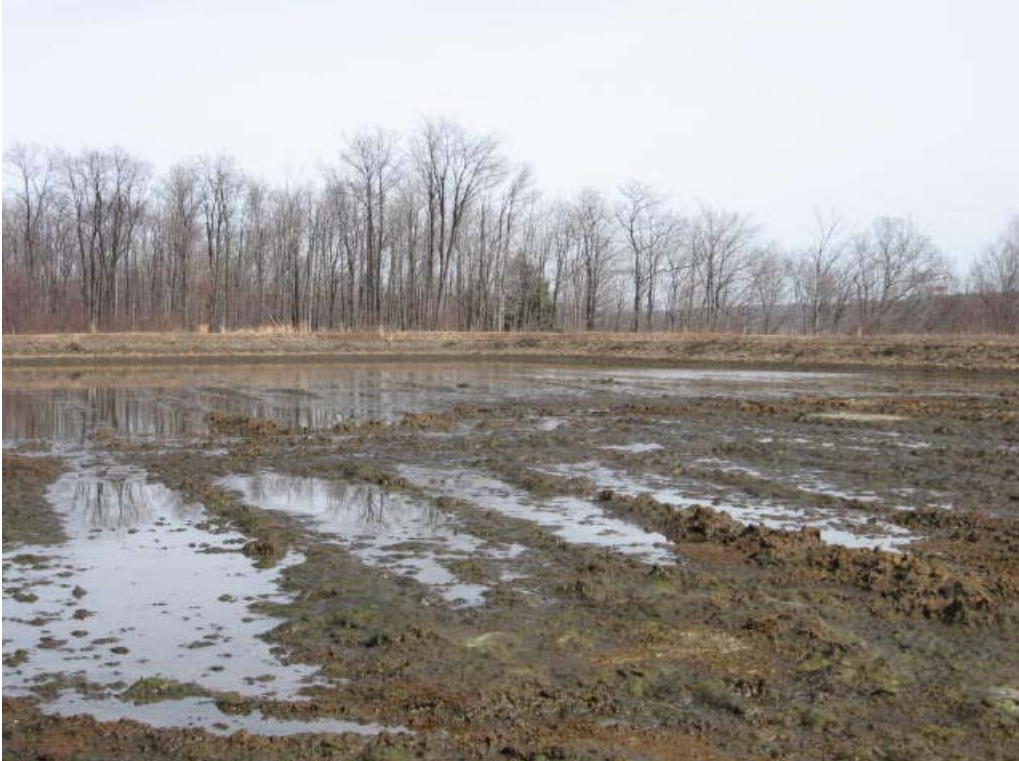
Photo 4. Standing water on top of organic substrate layer in drained Big VFP

Permeability loss is a major concern in the Big VFP. High flows frequently overwhelm the permeability of the system and untreated water is bypassed to the stream. The Small VFP is developing a similar permeability problem but it is not as apparent due to the fact that it does not receive large erratic flows.
