# **Muddy Run Passive Treatment Conceptual Designs, Beech Creek Township, Clinton County**

**Technical Report Provided by Hedin Environmental through the Trout Unlimited AMD  
Technical Assistance Program**

**July 2009**

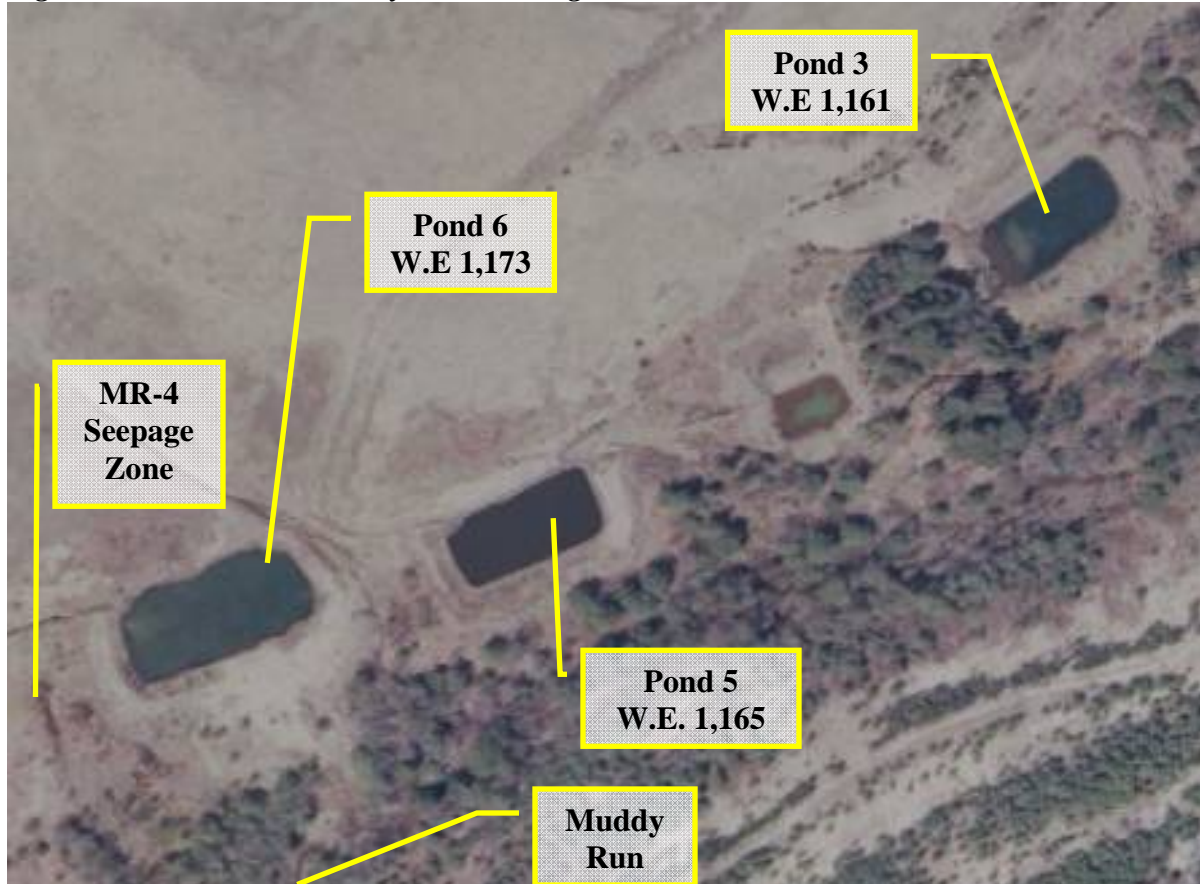
**Figure 2. MR-4 Treatment System Existing Conditions**

This system is intended to treat flow from the seepage zone around the westernmost existing pond in the study area (Pond 6). MR-4 and Pond 6 Out represent the discharges to be treated. Treatment of these discharges would address the first impacts to Muddy Run and provide buffering capacity to protect the stream from downstream acidic inputs. A vertical flow pond (VFP) that utilizes the existing ponds on the site is recommended.

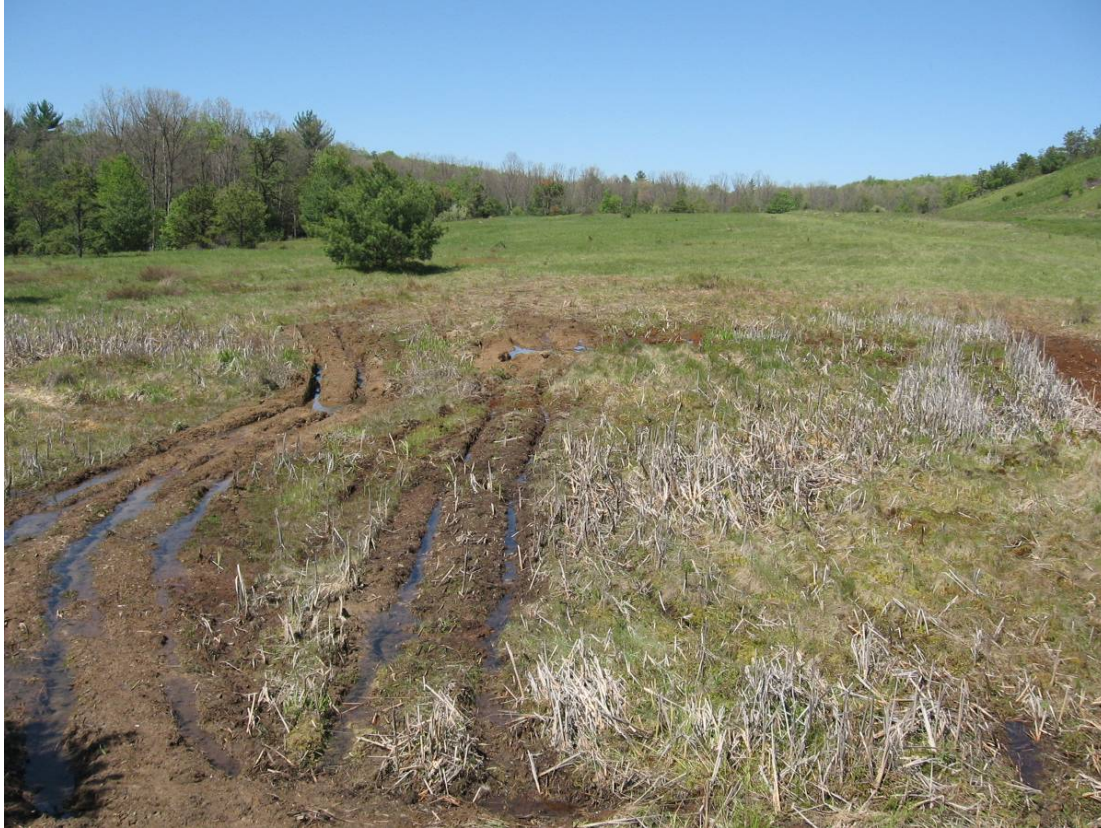
**Photo 1. MR-4 Seep Zone**

The first step in treatment is the collection of the MR-4 seep zone which appears to break out of an eroded ditch to the west of Pond 6 (Photo 1). Once collected, the discharge can be routed to Pond 6 for monitoring and treatment.

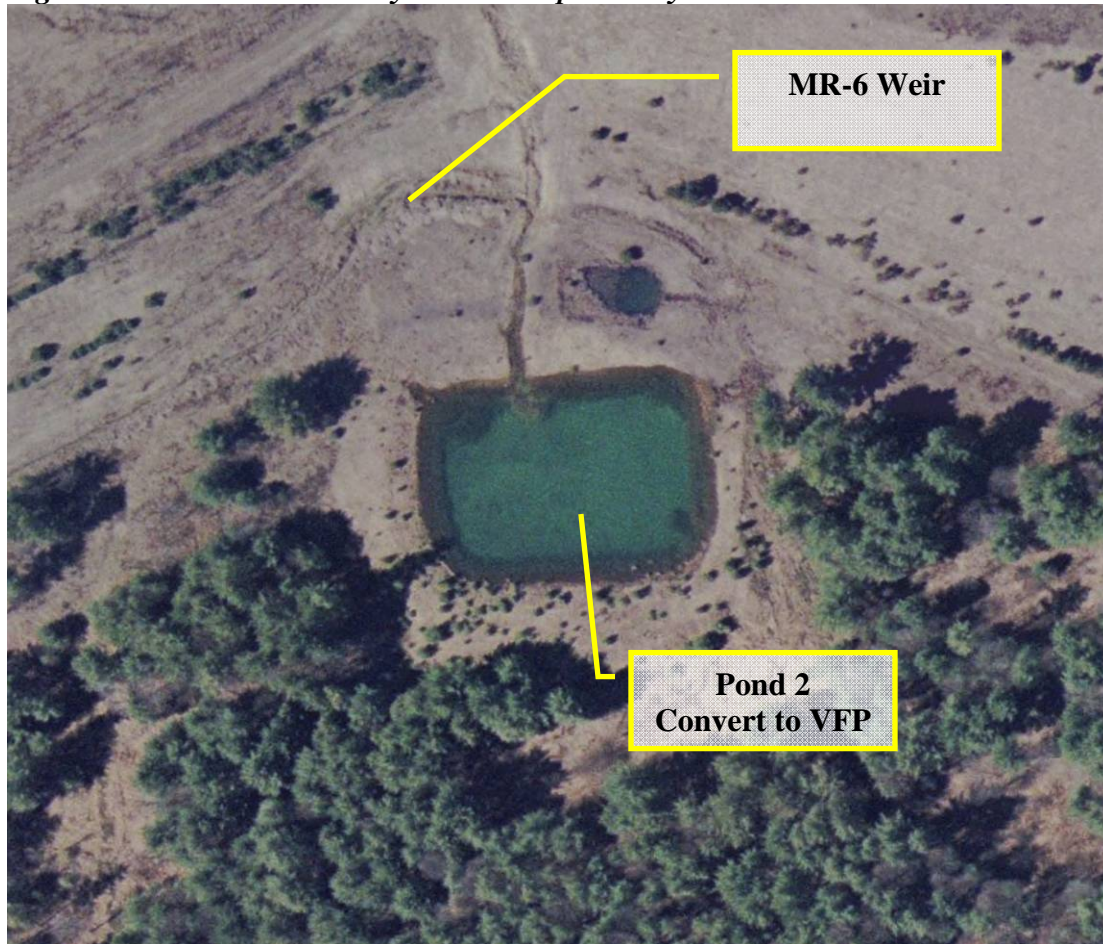
**Figure 4. MR-6 Treatment System Conceptual Layout**

The proposed system will consist of the converting the existing Pond 2 sedimentation pond to a vertical flow pond (VFP). Only Pond 1 is lower in elevation than Pond 2 so it would be the only available existing pond that could accept the effluent from Pond 2 for metals polishing or indirect treatment of additional discharges. However, Pond 1 appeared to have good water quality so there will be no advantage in piping the effluent from the MR-6 VFP to Pond 1. The effluent from the VFP will have very low metals concentrations so settling is not required. As a result, the VFP will discharge directly to Muddy Run. Figure 4 shows the MR-6 treatment system layout.

Table 6 shows the design assumptions and quantities for the MR-6 treatment system. The existing pond has a surface area of 21,000 ft<sup>2</sup> which leads to an acidity loading rate of 23 (g/m<sup>2</sup>)/day at the design flow rate of 84 gpm. The system will be under-loaded but as a result will require little to no maintenance. Similarly sized VFPs treating similar water quality have functioned with little to no maintenance for nearly a decade.
